DYNAMIC TESTS OF A PRESTRESSED CONCRETE MEDIAN BARRIER TYPE 50

SERIES XXVI

FINAL REPORT

CA-HY-MR-6588-1-73-06

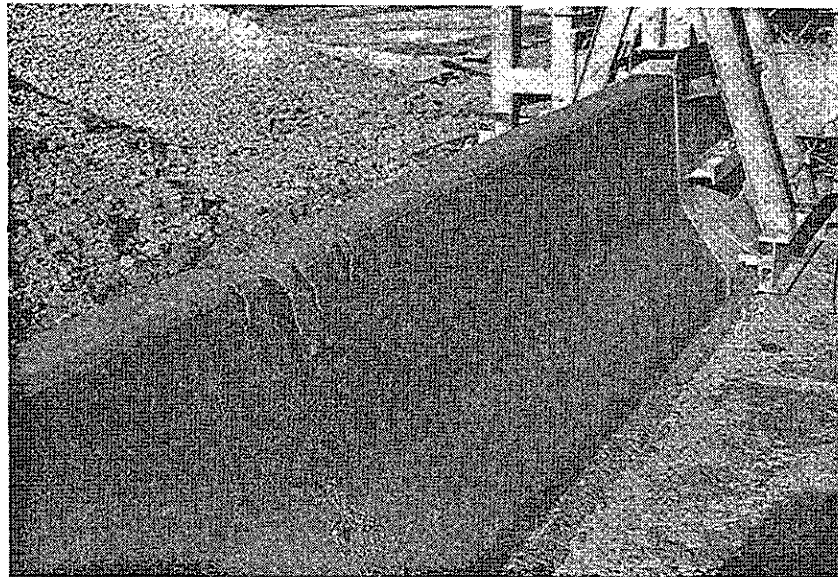
Proper placement of this barrier requires careful control of the concrete mix and, of course, proper control of the slipform equipment. For the slipforming process, the fresh concrete must possess very little slump while retaining workability. Improper control of the concrete mix can result in excessive slump or cracking as illustrated in Figure 5. After experimenting with several mix designs, the developer of the slipform equipment chose the following mix for the test barrier: a 3/4 inch maximum aggregate from California's Bear River; a water/cement ratio of 0.49; six sacks of Type II cement; and 17 ounces of water reducing admixture per cubic yard. The admixture successfully enhanced workability while maintaining a one inch slump during construction of the test barrier.

FIGURE 5, CRACKS RESULTING FROM
IMPROPER CONTROL OF CONCRETE MIX.

Having learned that conventional transit mix trucks could not discharge the stiff mix rapidly enough for the slipforming operation, the developer used special transit mix trucks with modified fins to increase the discharge rate. Fed by these trucks, the slipform equipment placed the test barrier at a rate of about four feet per minute with very little hand finishing required. Extensive hand finishing was required on the first two feet of barrier as the machine moved away from

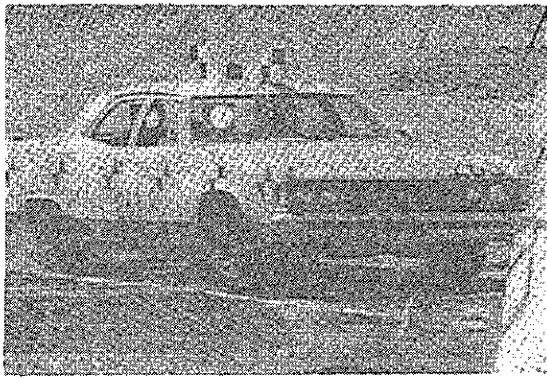
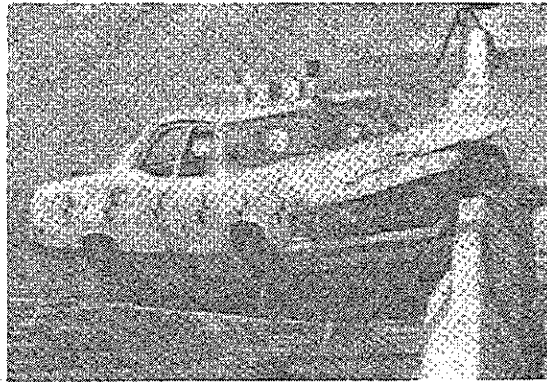
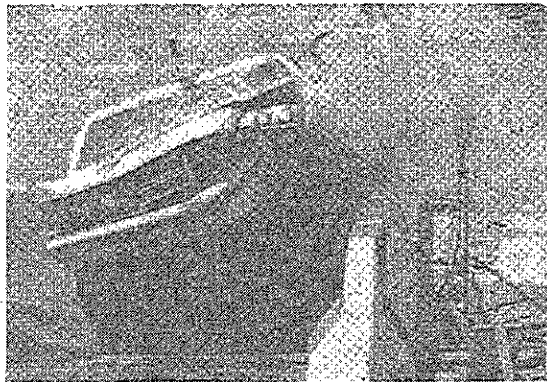
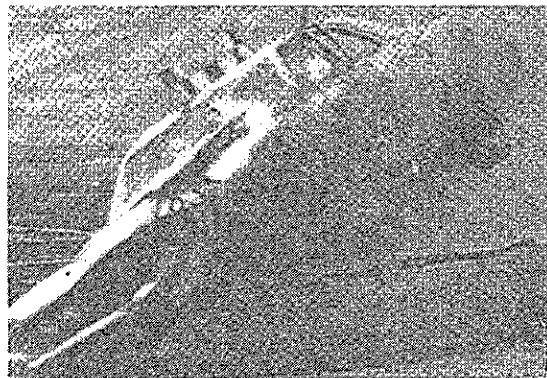
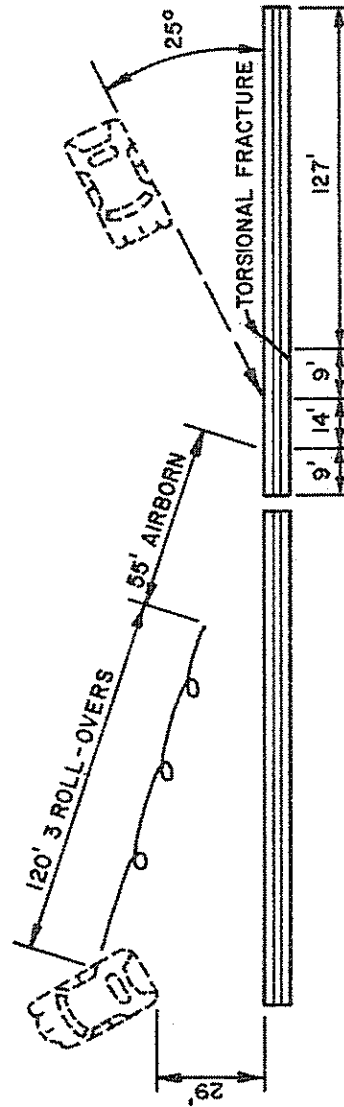
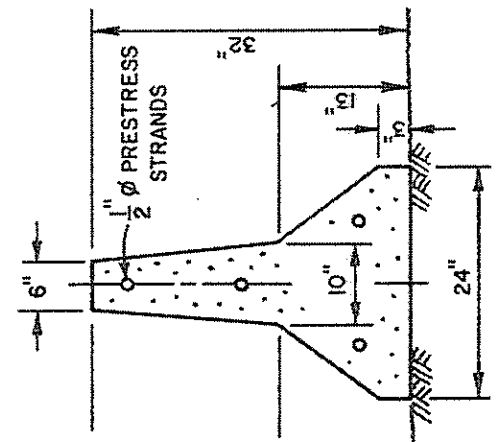
FIGURE II ,TEST 263

| BARRIER DAMAGE..... | Fractured | | |

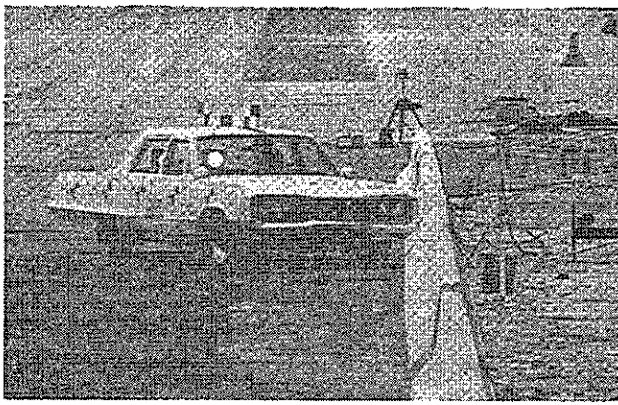
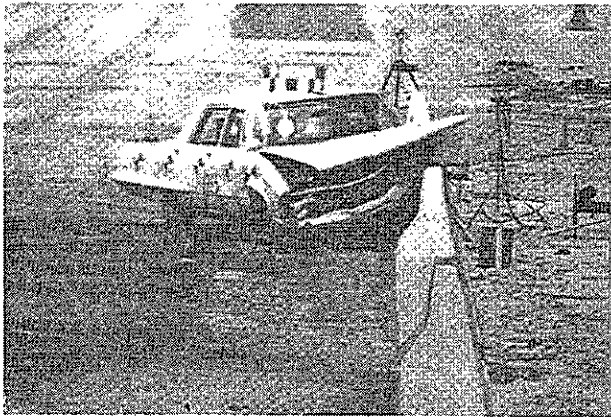
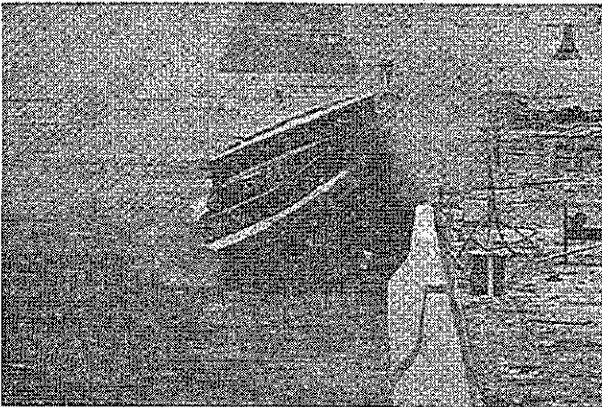
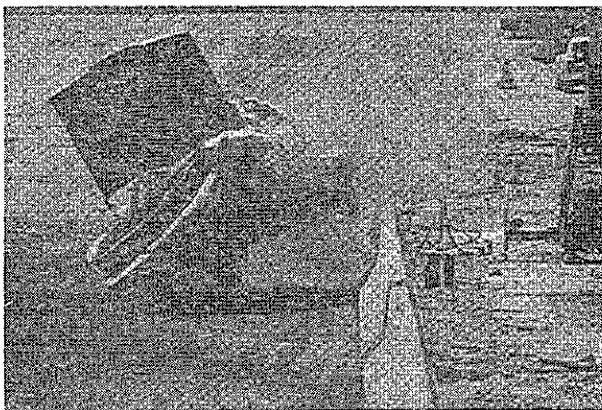
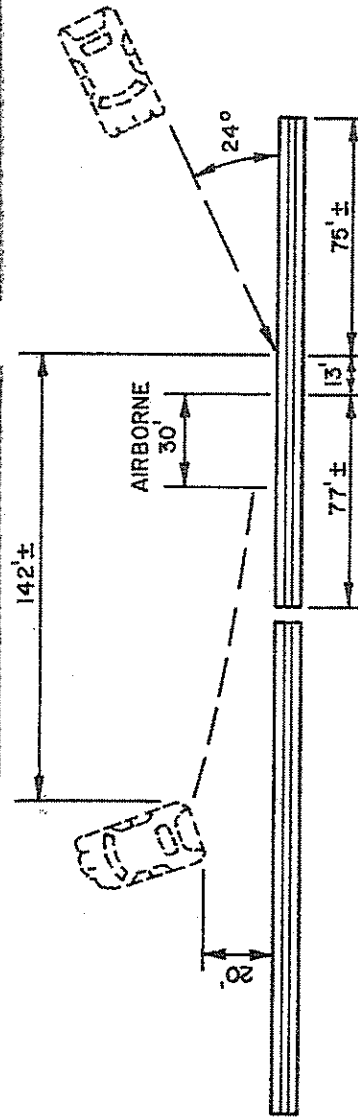
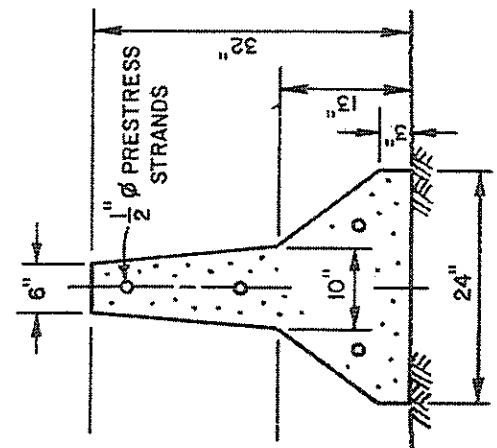
FIGURE 13, TEST 265
-19-

| BARRIER DAMAGE..... | Hairline fracture | | |

A 1968 Dodge sedan traveling at 62 mph hit the center of the barrier at an angle of 24 degrees. The response of the car was almost identical to that of the previous test and the only damage to the barrier was a hairline tension crack running vertically on the face of the barrier opposite the impact point. As shown in Figure 22 damage to the car was similar to, but a little more extensive than, the damage encountered in Test 264. The hood of the car was torn loose upon impact and the rear window shattered as the car landed after redirection. The dummy's response was not filmed during this test, but was probably similar to that of Test 264.

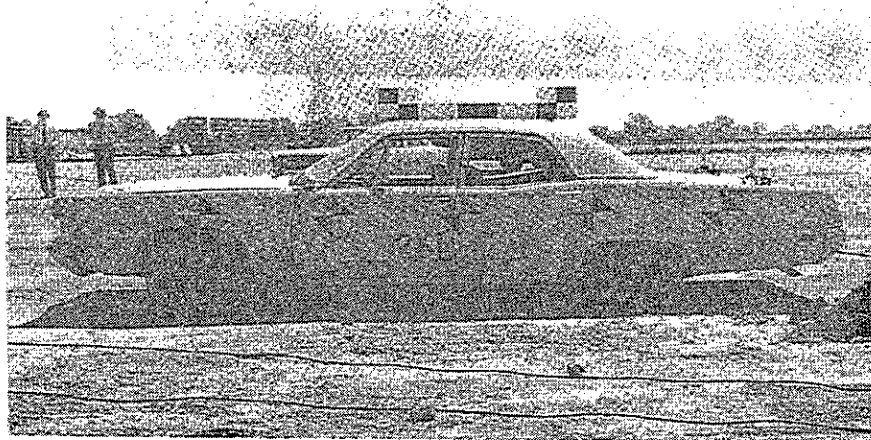
Vehicle damage was minor, consisting of slight deformation to the left fender and the left end of the front bumper and paint scratches along the length of the left side of the vehicle as shown in Figure 15. There was no mechanical damage to the

FIGURE 15, MINOR DAMAGE RESULTING FROM
9.5 DEGREE, 65 MPH IMPACT, TEST 261.

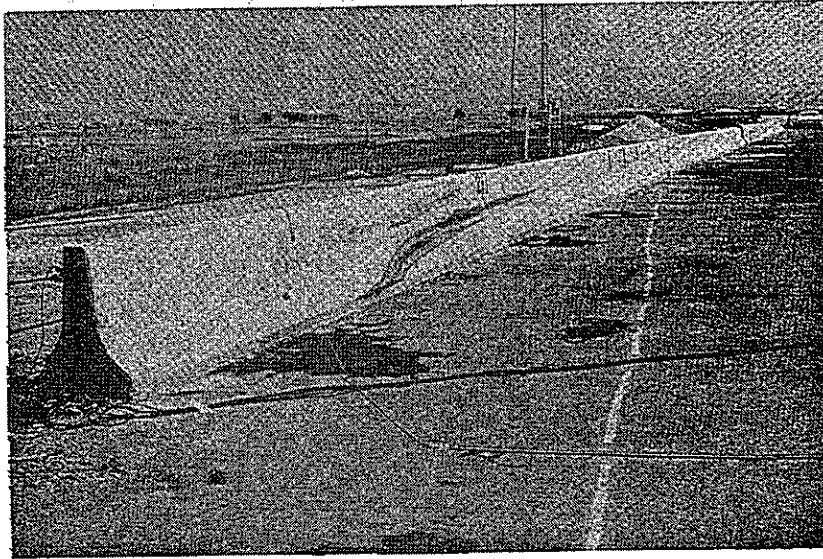
vehicle and it was used for a subsequent test the same day without any repairs. There was no barrier damage except for slight scratches and, of course, tire and body marks as shown in Figure 16.

FIGURE 16, TIRE AND BODY MARKS FROM
9.5 DEGREE ANGLE IMPACT, TEST 261.
NOTE FINAL LOCATION OF CAR.

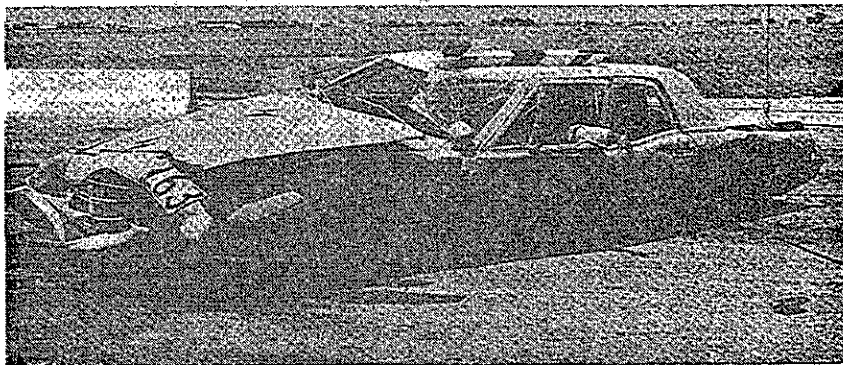
Although the car damage due to impacting the barrier was primarily confined to the left front end, the remainder of the car was totally destroyed by the three roll overs. As shown in Figure 18 the upper framework was severely distorted but the passenger compartment remained intact with the doors locked. Barrier damage was limited to minor scratches in the impact area and tire marks as shown in Figure 19.

FIGURE 18, TYPICAL DAMAGE RESULTING FROM TESTS 262 AND 263.

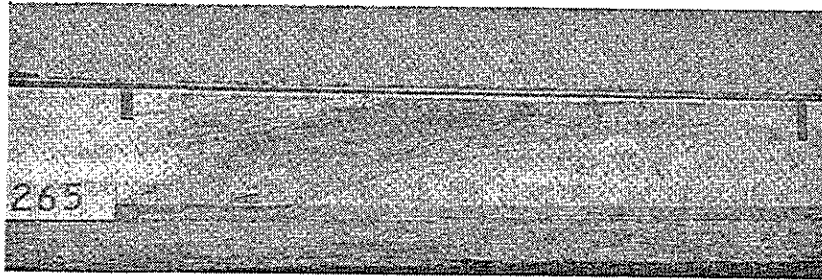
FIGURE 19, TYPICAL TIRE AND BODY MARKS FROM 25 DEGREE IMPACT.

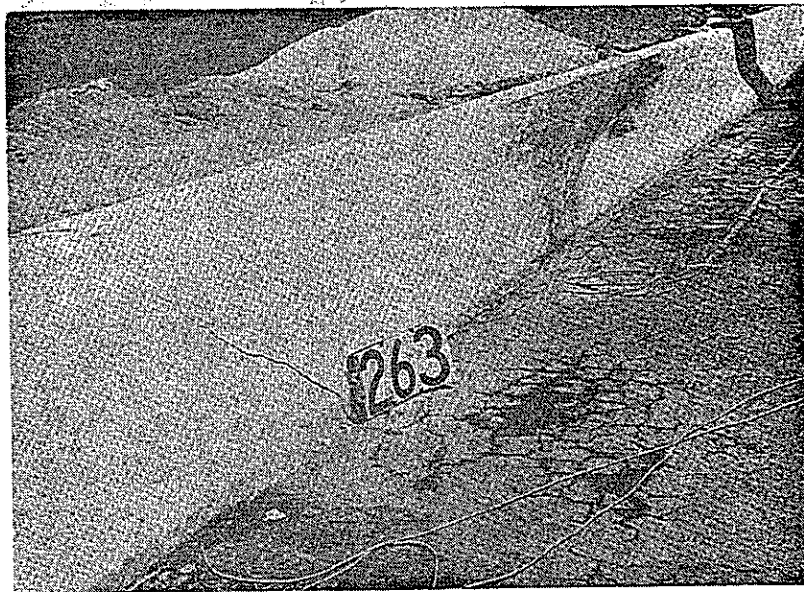
Although the barrier successfully retained and redirected the car, it suffered what appeared to be a torsional fracture completely through the concrete section about 9 feet upstream of the impact point as shown in Figure 21. The prestressing strand did not allow the barrier to separate and restricted the movement of the free end to a lateral movement of about 5/16 inch at the top and no lateral movement at the base. Because this movement was small, the barrier was able to perform effectively, but its ability to sustain subsequent severe impacts was significantly reduced. Therefore, the construction plans presented in the Appendix require a reinforced cast-in-place joint in order to provide adequate structural continuity through the joint. The fracture plane was injected with epoxy prior to the next test in an attempt to restore the full continuity of the test barrier.

FIGURE 21, TORSIONAL FRACTURE RESULT-
ING FROM IMPACT NEAR JOINT.

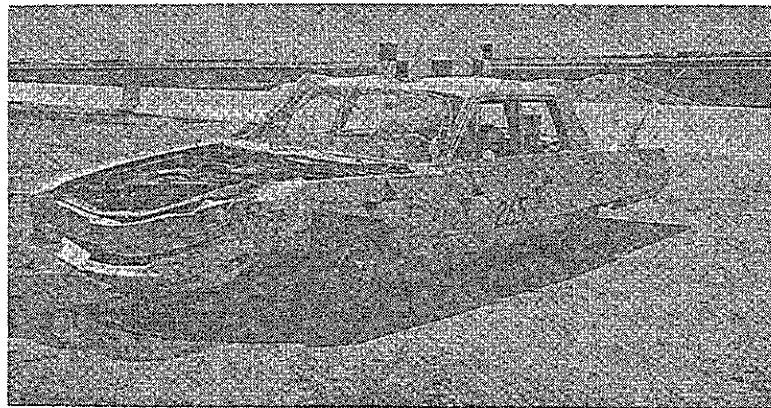
A 1969 Dodge sedan traveling at 64 mph hit the center of the barrier at an angle of 25 degrees. The redirection of the car was very similar to the two previous tests except that the car did not roll over. As the car left the barrier, it traveled about 20 feet nearly airborne. Upon landing the weight of the car seemed to be carried by the entire left side of the car as opposed to the previous tests where the car tended to land on its left front. Following the landing, the rear of the car bounced high throwing the weight of the car onto its left front but not enough to make it roll over. As shown in Figure 22, the vehicle suffered severe damage to its left front area, but its exterior was otherwise undamaged except for sheet metal damage along its left side. There was no damage to the barrier.

FIGURE 22, TYPICAL DAMAGE RESULT-
ING FROM TESTS 264 AND 265.
